Errickson Home Inspections, LLC
4007 Thrushwood Lane
Minnetonka MN 55345
612-991-4309
jon@erricksonhomeinspections.com

Confidential Inspection Report

**2112 Main St
Anycity, MN 55345**

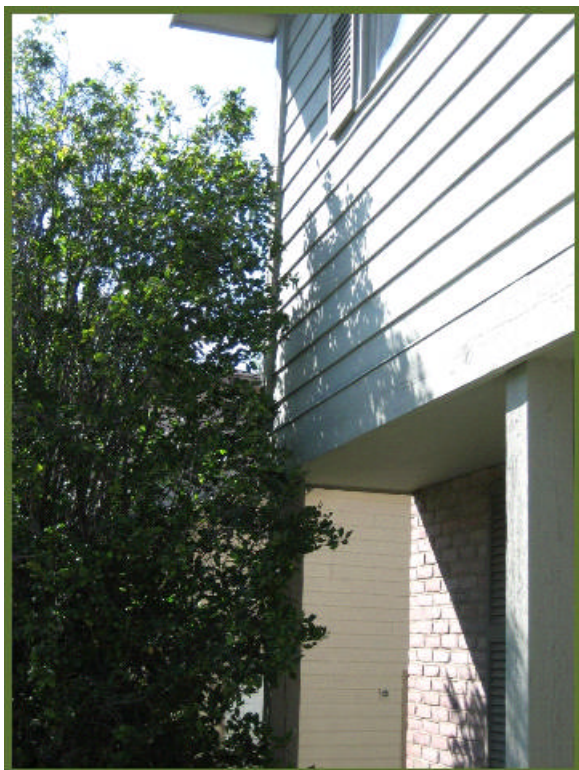
Trees/Shrubs:

Condition: Defective, Shrubs are too close/rubbing against the exterior siding. Recommend trimming shrubs at least 12" from wall.

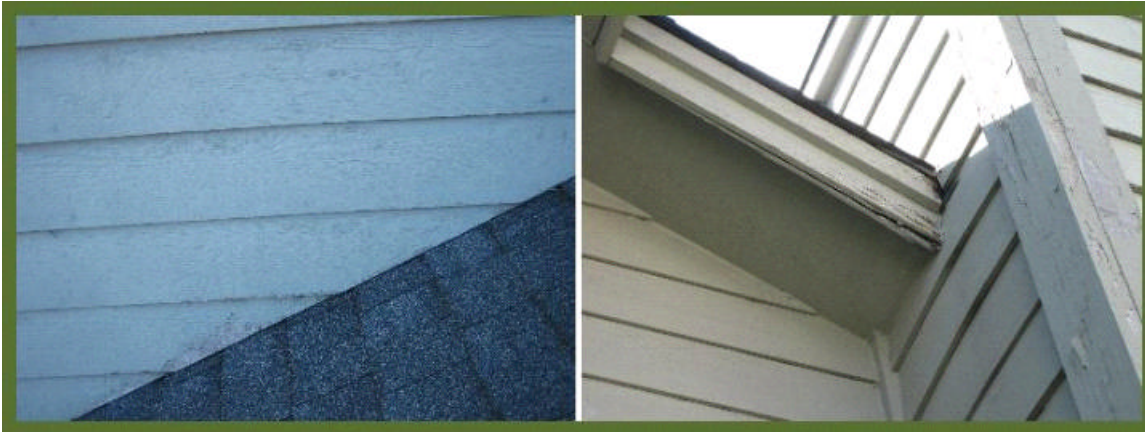
Materials & Condition:

Marginal, Walls are wood frame clad with brick veneer and hardboard siding. Lacks paint or stain, Peeled paint, Siding materials contacting roof. There should be at least a 1" gap between siding and roof shingles. Decayed or worn wood. Repairs/replacement by a carpenter recommended.

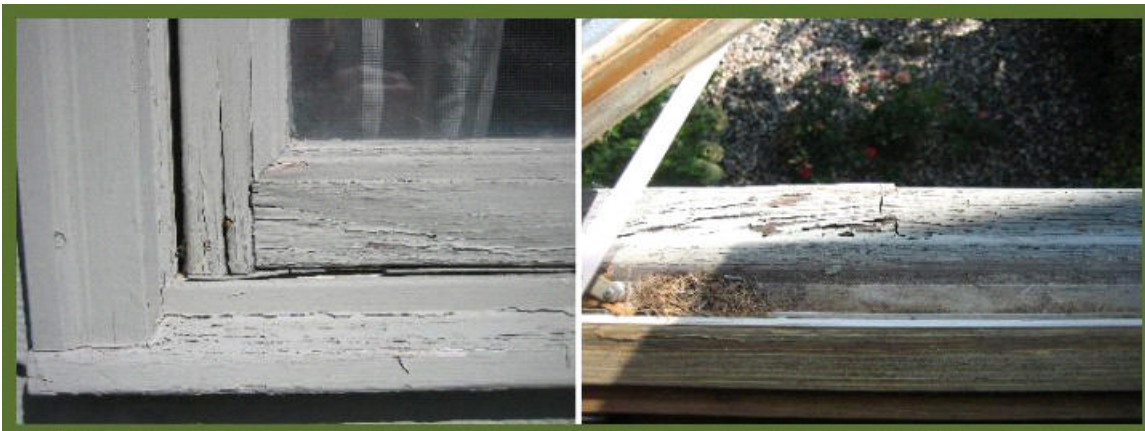
Flashing & Caulking:
Windows

Functional.
Marginal, Sill/sash showing signs of rot. Recommend repairs/replacement.

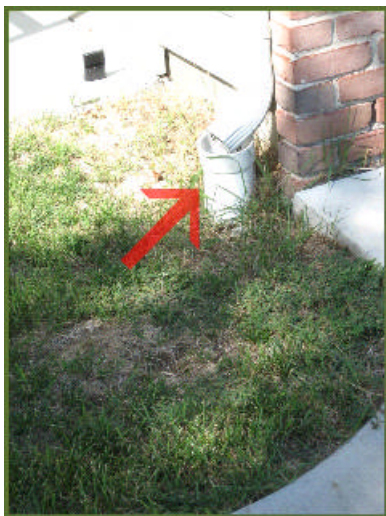
Gutters & Downspouts:

Defective, gutters are only partial, and sloped improperly. Recommend installing gutters and downspouts to help with site drainage and having the gutters that are already on the house repaired so they slope properly. Subsurface drains noted - not able to determine where they outlet. Recommend inquiring with the seller where the drains outlet.

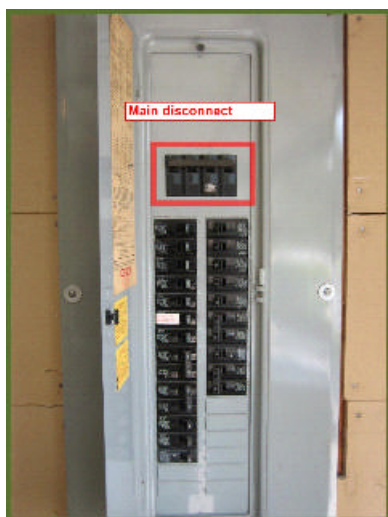
Main Panel Observations:

Defective, Pointed screws on panel cover. Recommend replacing pointed screws with blunt-tip screws.

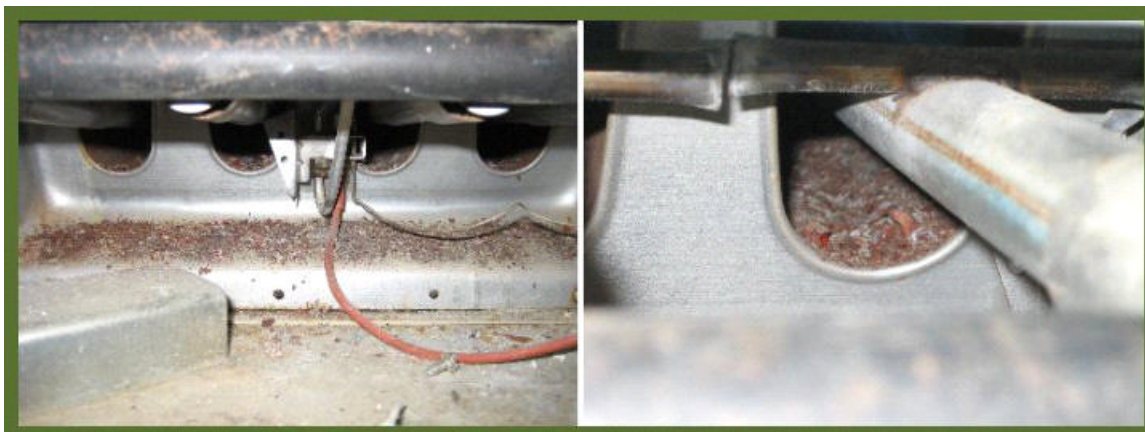
<i>General Operation & Cabinet:</i>	Defective. Major corrosion is noted. Unit lacks proper amount of combustion air (for a 100,000 BTU furnace, it needs at least a 625 s.f. room). This creates an unsafe condition that could lead to spillage and backdrafting. Further evaluation/replacement recommended by a licensed HVAC contractor.
<i>Burners / Heat Exchangers:</i>	Defective, Excessive scale and corrosion is noted in the burn chamber, soot/charring noted in burn chamber. System lacks make-up air. Contact a licensed HVAC contractor for further evaluation and replacement.

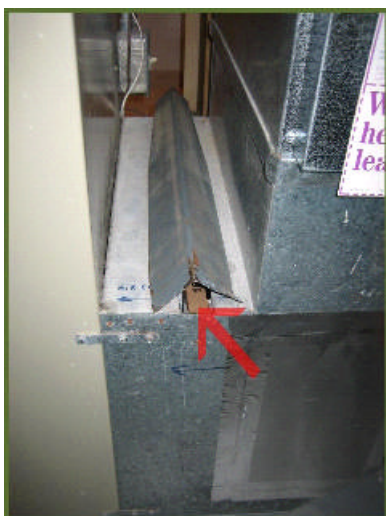
Air Filters:

Marginal. Air filter slot needs a proper cover.

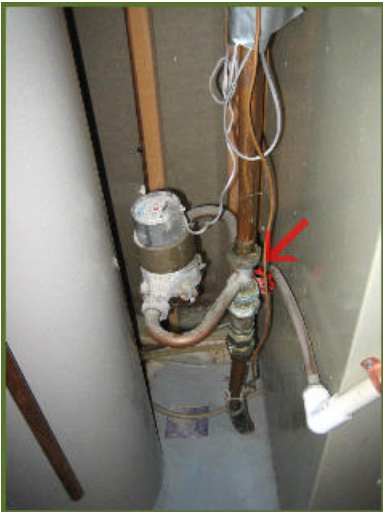
Shut Off:

Main shutoff valve is located next to water heater.

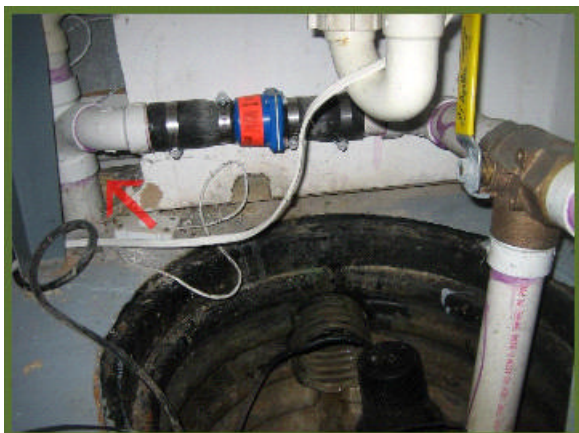
Sump Pump:

Defective. The sump pump ejects directly into sanitary waste system. Most municipalities do not allow this. Recommend inquiring with the sellers if they have a permit to eject directly into the sanitary waste system, if not, repairs are recommended.

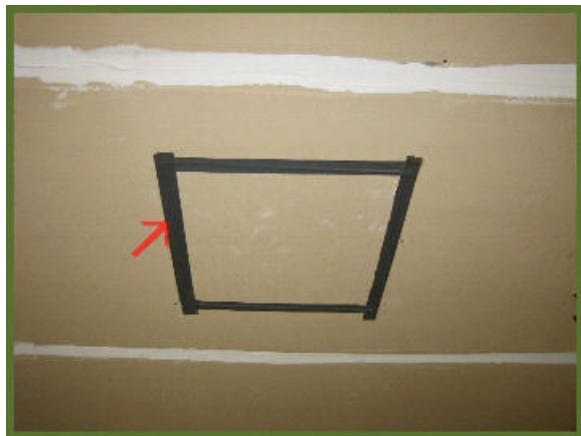
Roof:*Condition:* Same as house.**Ceilings:***Condition:* Functional.**Garage Door:***Material - Condition:* Functional, Metal.*Door Operator:* Functional, Automatic reverse feature is, operational.*Service Doors:* Functional.**Garage Exterior Walls:***Materials & Condition:* Same as house - See house report.**Garage Walls:***Type & Condition:* Functional, Drywall.*Separation Wall* Marginal, Repair any openings with approved materials to restore its fire rating.
